## Case Study Abu Qir Fertilizer Plant

Application:	Fertilizer Plant
Location:	Egypt
Year:	2017
Instrumentation involved:	Hard Rubber Lined Pipes
Provided Solution:	On Field Analysis, Planning & Intervention

The client asked for valveIT support concerning problems occurred on hard rubber lined pipes used for abrasive fluid. In details, damages referred to:

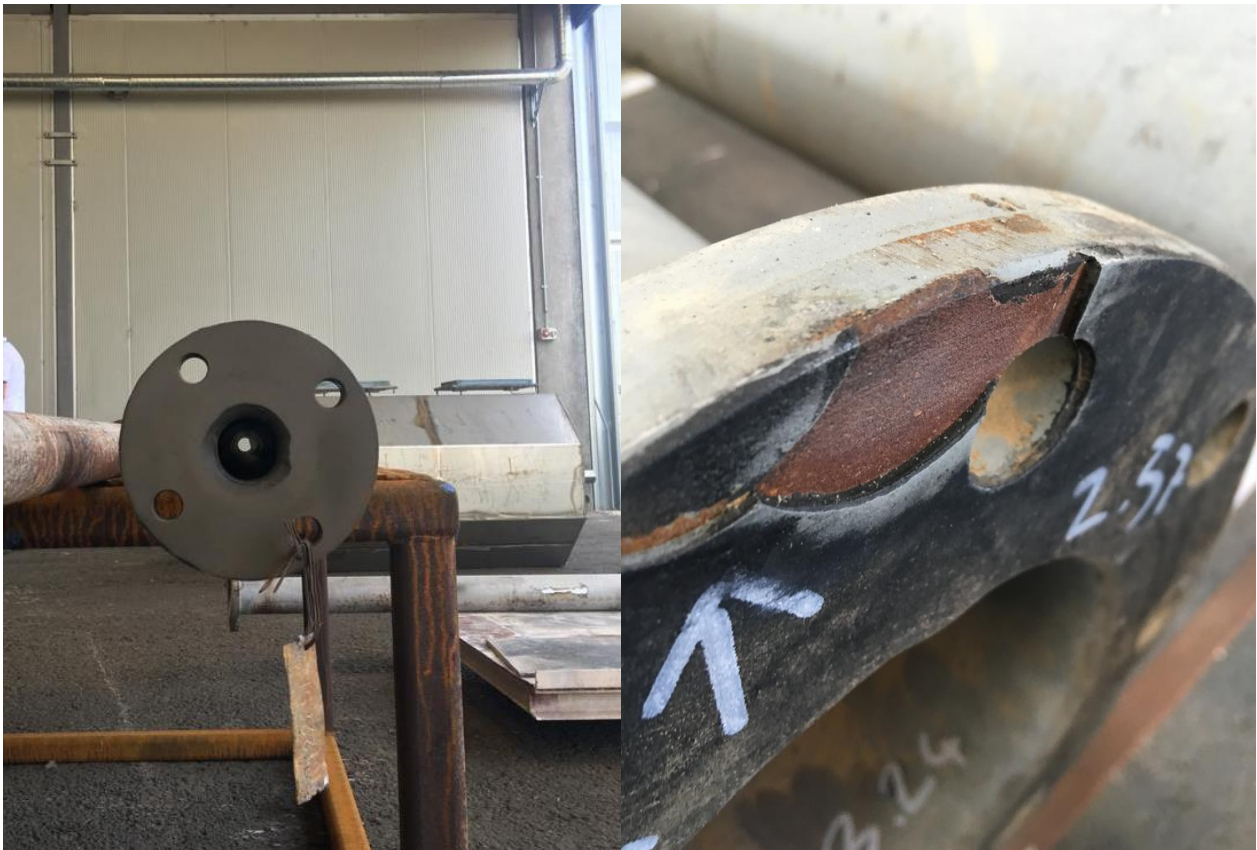
- a) Adhesion of hard rubber on pipes

Figure 1.2 Adhesion Problems with Abu Qir's Hard Rubber Pipes

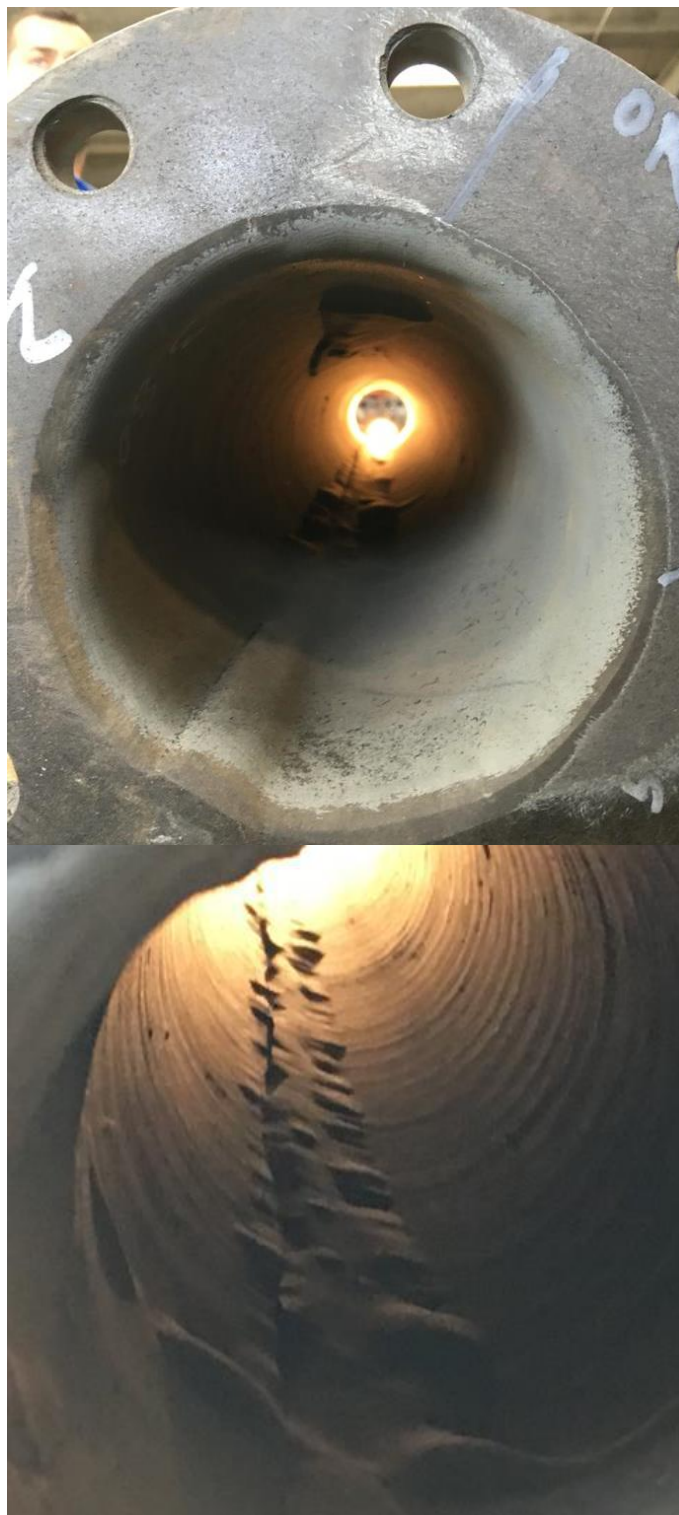
b) Arising of bubbles between lining and pipe body

*Figure 1.3 Non-performing Bubbles arising between Body and Lining of the Abu Qir Fertilizer Plant*

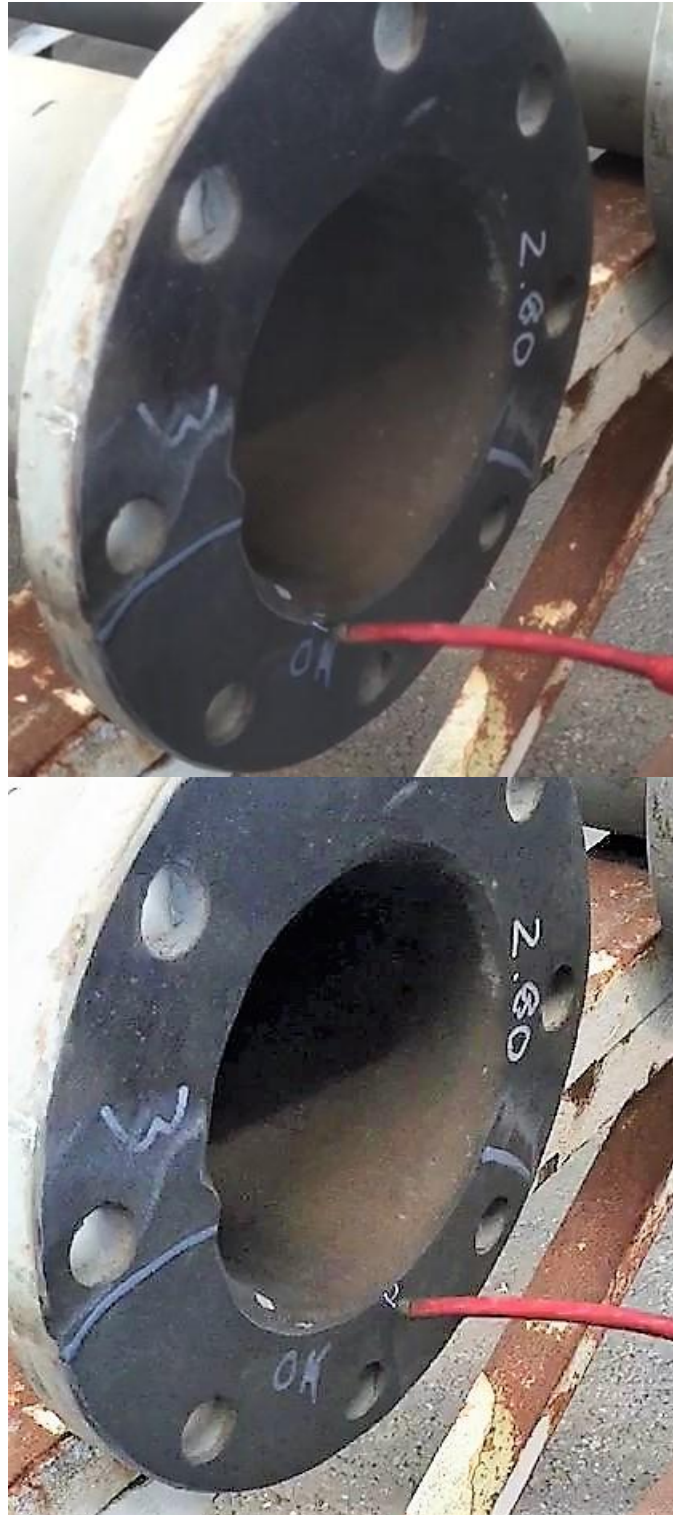
## c) Conductivity of the rubber surface & Failure of the Spark Test

*Figure 1.4 Spark Test Failure for Abu Qir's pipes due to the Conductivity on their rubber parts*

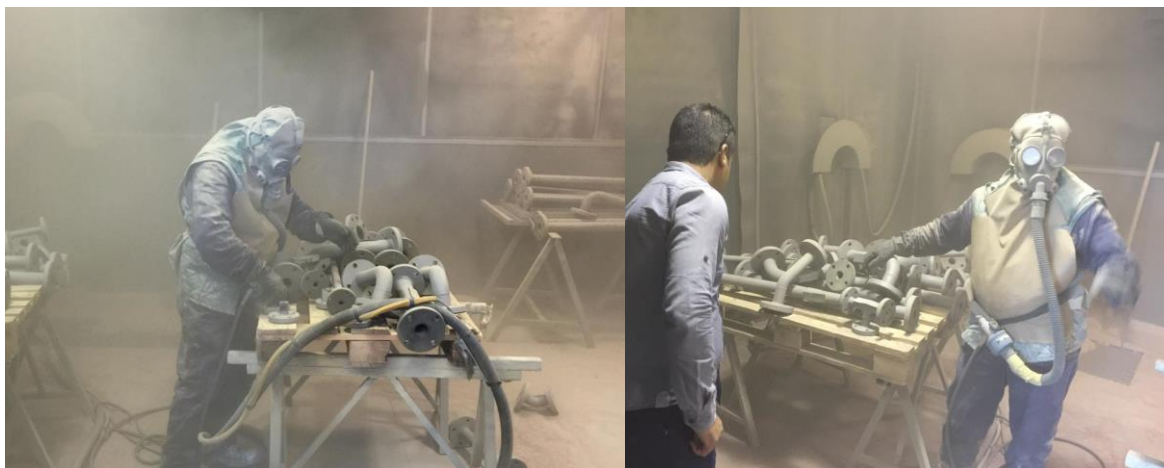
Figure 1.5 Damaged Pipes are cleaned and restored through Heating, Air Flushing and Sandblasting processes

- a) Removing of previous lined material with pyrolysis process & Removing of previous rubber by pipe heating & air flushing. Subsequent Internal & External Sandblasting of the pipes

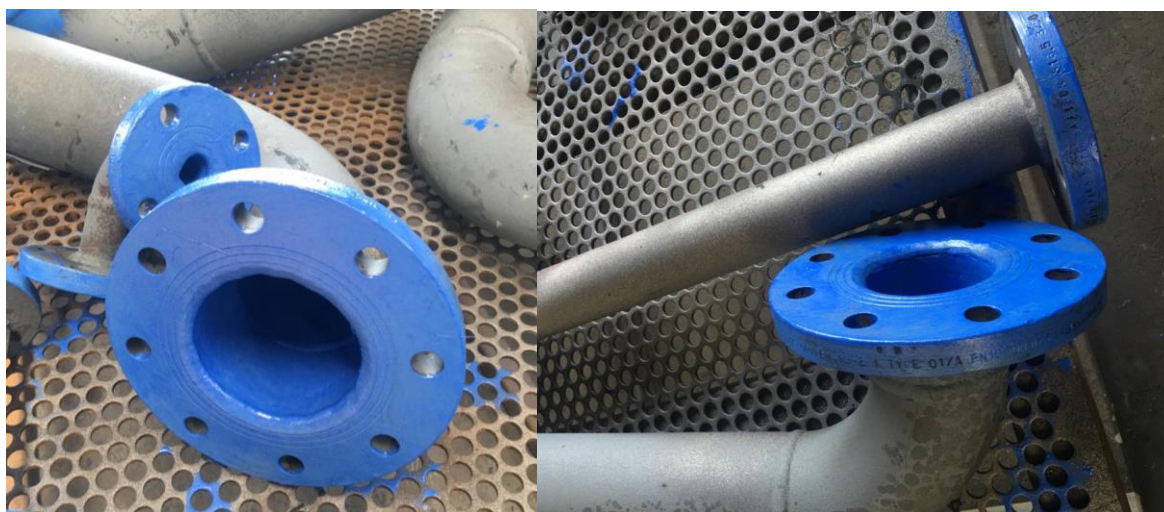
Figure 1.6 New Adhesion on the pipe surface is obtained thanks to the application of a special glue on it

- b) Application of special chemicals glue for adhesion purpose

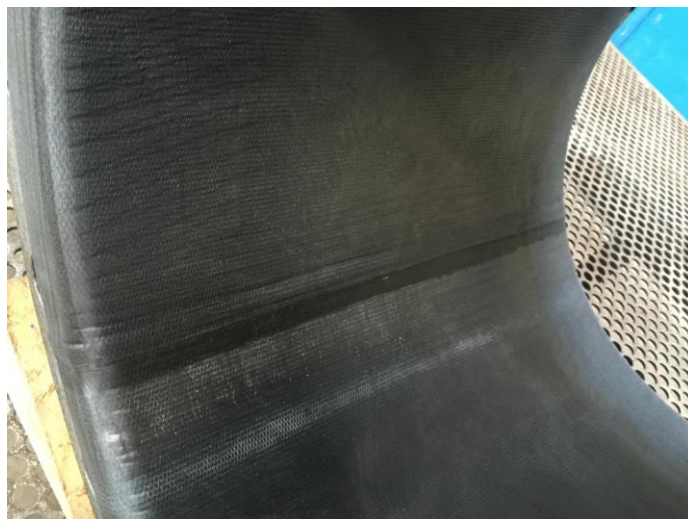
*Figure 1.7 New rubber coverage is applied on the pipe*

## c) Application of adhesion new rubber

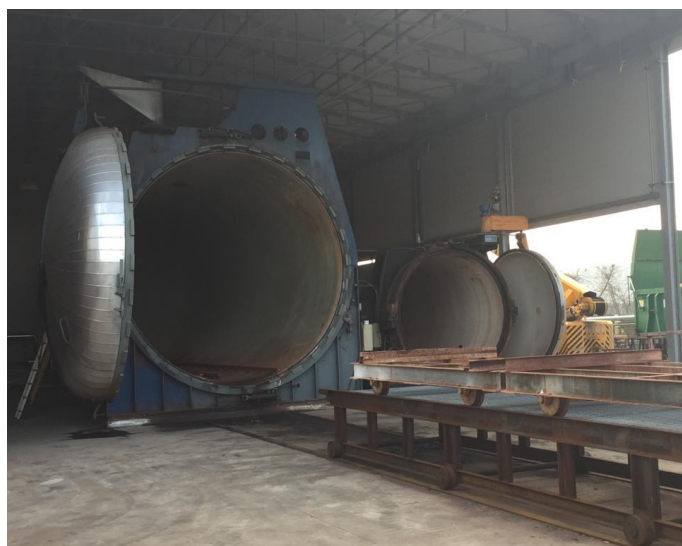
*Figure 1.7 Rubber is finally fixed through the Vulcanization method*

## d) Autoclaving for Vulcanization process
